Nuisance Flooding Plan for Calvert County

October 1, 2020

This Nuisance Flooding Plan was prepared by Calvert County's Department of Planning & Zoning with contributions from the Department of Public Works, Department of Public Safety, Department of Parks & Recreation, Soil Conservation District, and the Calvert Marine Museum

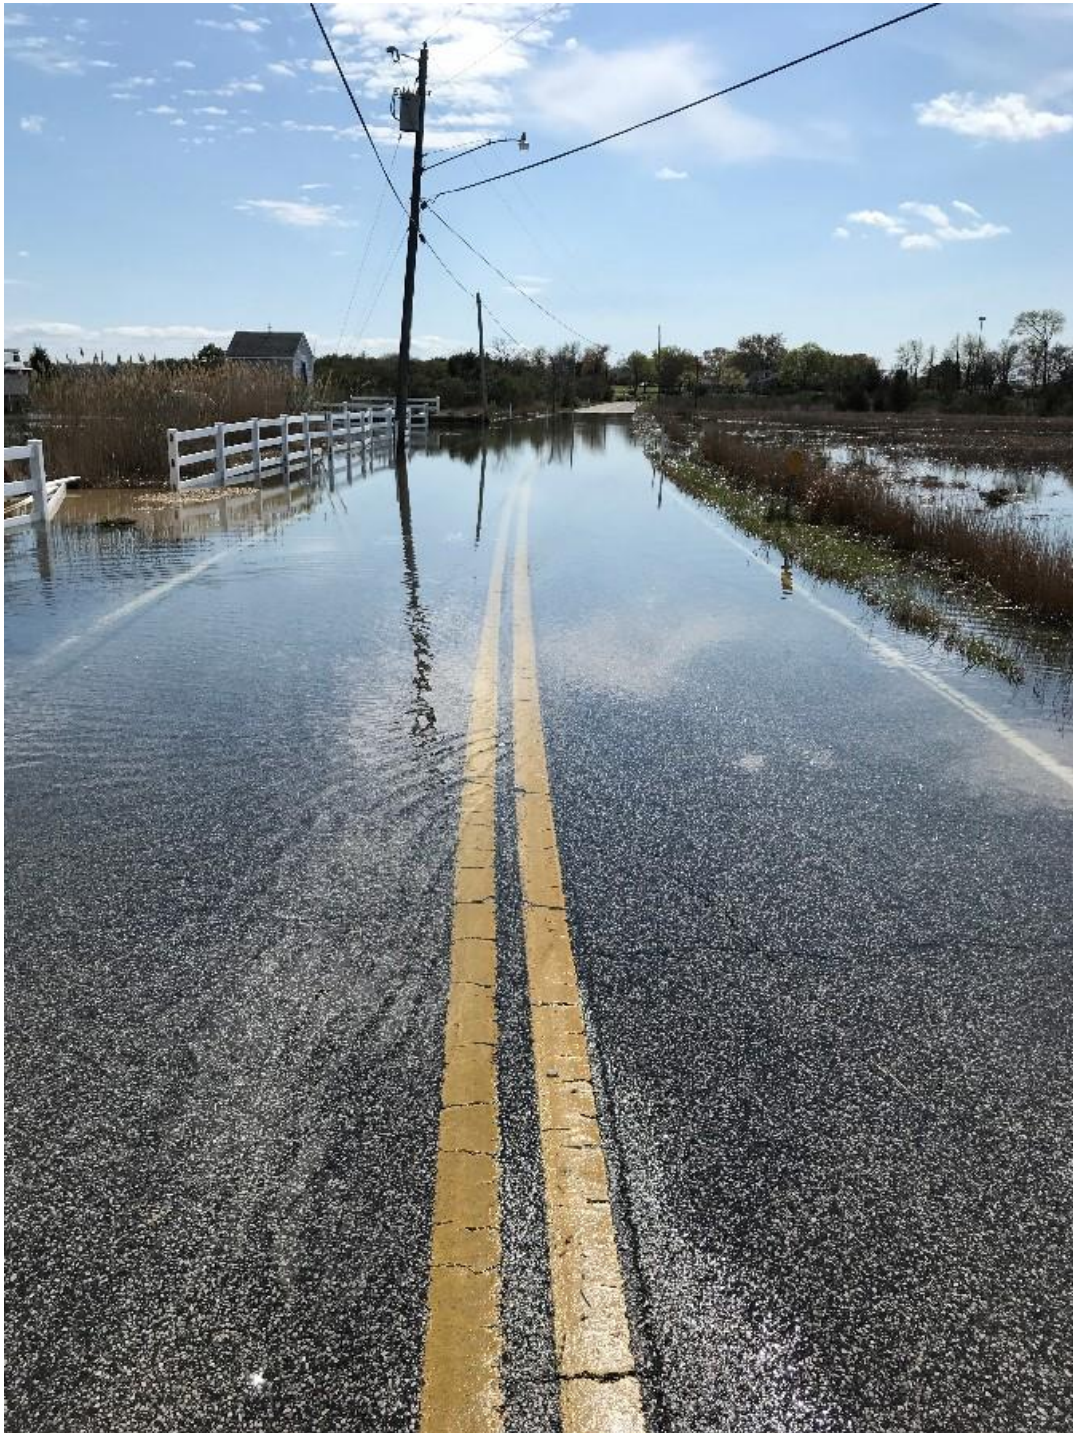
Figure 4 Tidal Flooding on Broomes Island Road

Caption: Photo was taken around 2:30 pm on April 5, 2020. High tide was recorded at 1:17 pm at 1.7 feet above sea level. There was about 4.5 inches of water above the centerline at the two lowest points. A Coastal Flood Warning from the National Weather Service was in effect that day. Photo courtesy of the Calvert County Department of Public Works

During the development of the *Broomes Island Flood Mitigation Plan (2016)*, Calvert County DPW looked into flood mitigation options for Broomes Island Road. It was recommended to consider elevating the Broomes Island Road Causeway and a contiguous section of Broomes Island Road to the north by 4.5 feet over a length of 5,926 feet. The plan stated that this undertaking would alleviate tidal nuisance flooding as well as flooding associated with many prolonged rain events and would have an estimated cost of \$1.5 million not taking into account reviews, studies, and permits required by state and federal agencies which would need to be determined and factored into the total amount. However, upon further review by DPW this initial projected cost is likely to be an underestimation. In addition to expense, the complications associated with such a project which would likely include the acquisition of private property as well as the disturbance of wetlands could make implementation a challenge.

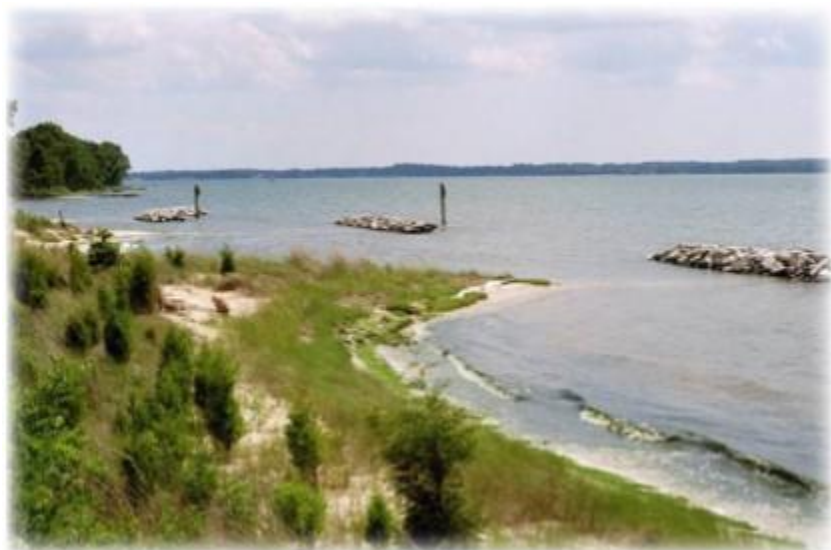
Figure 5 Living Shoreline at Jefferson Patterson Park and Museum

Caption: Living shoreline practices have been used at Jefferson Patterson Park and Museum; a part of the Maryland Historical Trust. The living shoreline shown above includes a segmented stone breakwater with marsh plantings shoreward of the breakwater and is built near and parallel to the shoreline to reduce wave energy on the land side of the structure. Source of the photo is the Jefferson Patterson Park & Museum

Living shorelines are a form of green infrastructure typically consisting of native vegetation, stone, sand fill, or other organic and structural materials and are considered an adaptation tool to sea level rise by the Maryland Commission on Climate Change. Living shorelines are designed to reduce wave energy, trap sediment, and filter runoff while maintaining or increasing the beach and/or coastal habitat. Hard shoreline structures like seawalls, bulkheads, and revetments serve as a fixed barrier between land and coastal environments. These practices can limit the impacts of flooding but also disrupt natural processes. The use of living shorelines as opposed to hard shorelines is preferred by the Maryland Department of Natural Resources. Living shorelines function more to stabilize shorelines and reduce the rates of erosion, but in flood-prone areas with the right physical conditions, living shorelines can help control flood waters by storing them and allowing a slow release back into the Chesapeake Bay, Patuxent River, or groundwater. The effects of living shoreline projects on erosion and flooding in the county is something that could be studied.

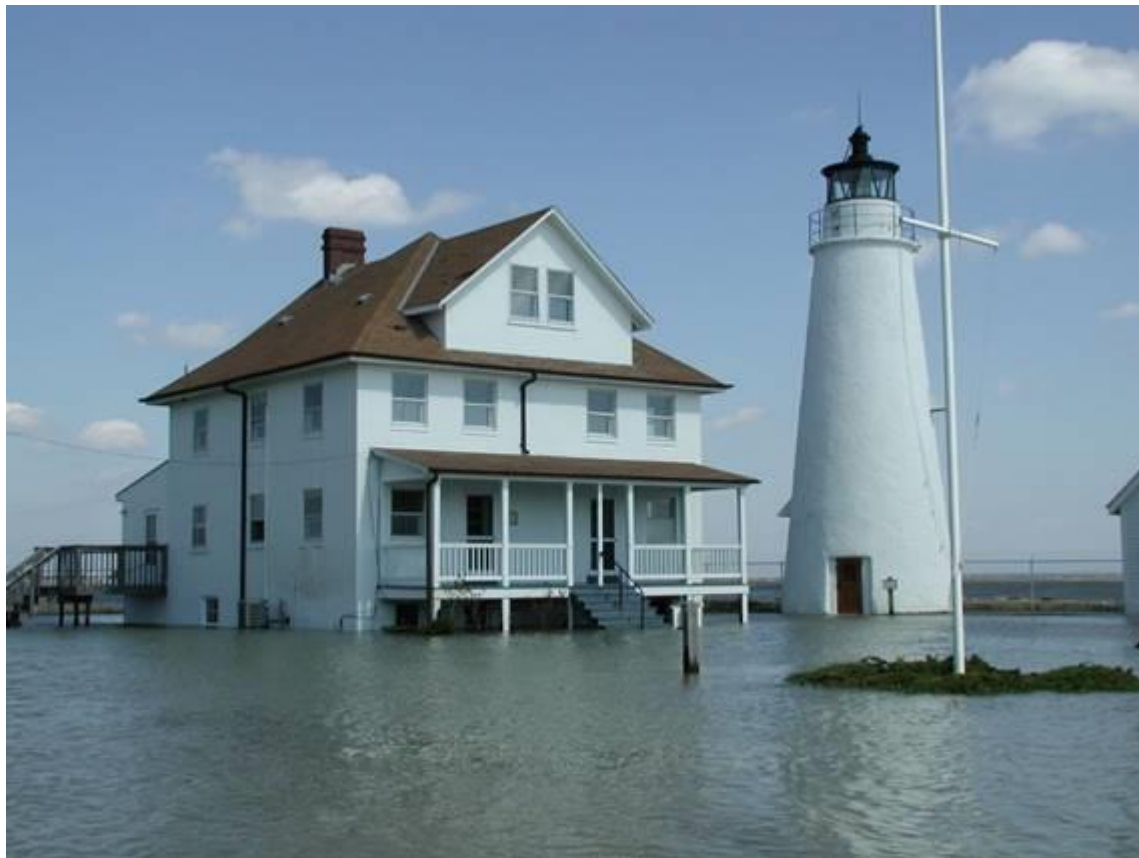
Figure 7 Flooding at the Cove Point Lighthouse and Keeper's House

Caption: This photo of tidal waters at the Cove Point Lighthouse and Keeper's House was taken after Tropical Storm Isabel hit Calvert County in 2003. Photo courtesy of the Calvert Marine Museum

The Cove Point Lighthouse was constructed in 1828 and is the oldest continuously operating lighthouse on the Chesapeake Bay. Throughout its history the keepers of the lighthouse have worked persistently to mitigate against the natural forces of the bay. The earliest reference to erosion was in 1831 and by the 1840's a wooden breakwater and groin field were constructed around the keeper's house and tower. In 1913 a reinforced concrete seawall was constructed, which was rebuilt in 1993³. Ownership of the Cove Point Lighthouse and Keeper's House was transferred from the U.S. Coast Guard to Calvert County Government in 2000 and the property is administered by the Calvert Marine Museum (the Coast Guard continues to operate the aids-to-navigation functions of the lighthouse). The county installed a sump pump in the keeper's house after it was flooded with tidal water from Tropical Storm Isabel in 2003 and it currently provides adequate flood mitigation. However, this site is vulnerable to sea level rise and increased tidal flooding. At some point in the future, elevation of the keeper's house is an option that could be explored.

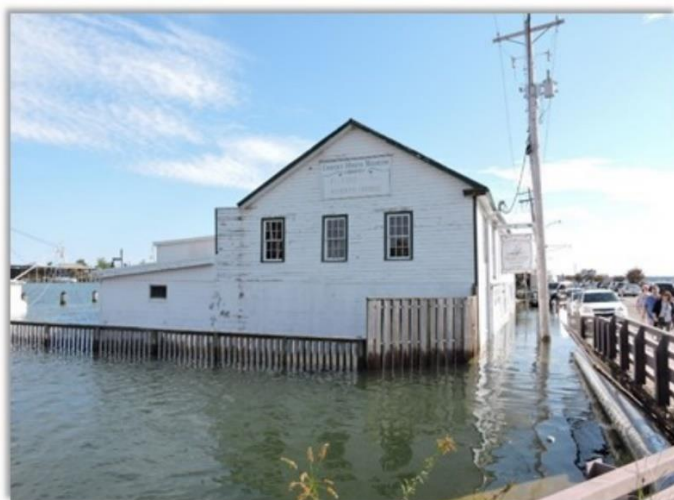
Figure 8 Flooding at the Lore Oyster House

Caption: The Lore Oyster House Museum experiences nuisance flooding so frequently that it must close for a period almost every day it is open. Photo courtesy of the Calvert Marine Museum

The Lore Oyster House was constructed in 1934 following the destruction of the previous company building in the Chesapeake-Potomac Hurricane of 1933. Of all the oyster-packing companies operating along the Patuxent River between 1867 and 1984, the Lore Company possessed the second largest and the longest continually operating plant. Few oyster houses from this period have survived essentially unaltered. The Calvert Marine Museum acquired the property in 1979 after the Lore Company ceased business. The oyster house was built on top of “new land” created by oyster shell fill from previous operations. Concrete walls were used in order to minimize flood damage to the building. The concrete slab floors required frequent cleaning by water hose and have sloping surfaces for self-draining⁴. Today, water from Back Creek enters the building through this floor drain at high tide.

The county investigated flood-proofing the Lore Oyster House, potentially utilizing FEMA’s post-disaster declaration grant funds, which include a 25 percent cost-share. The installation of a one-way valve would mitigate some of this flooding. Installation of floodgates at doors and sealing the foundation areas could mitigate additional flooding that enters from tidal waters surrounding the building. At this time, it is not known precisely how much of the flooding can be attributed to water coming up through the floor drain and how much can be attributed to water entering the building from the outside. One way to determine this would be to sandbag the building and observe how it affects the flooding. Presently, there are some days where floodwaters inside the building are two and a half feet or higher. While tidal flooding impacts the ability of visitors to tour the oyster house, it is not structurally compromising and the stability of the building is not in question.

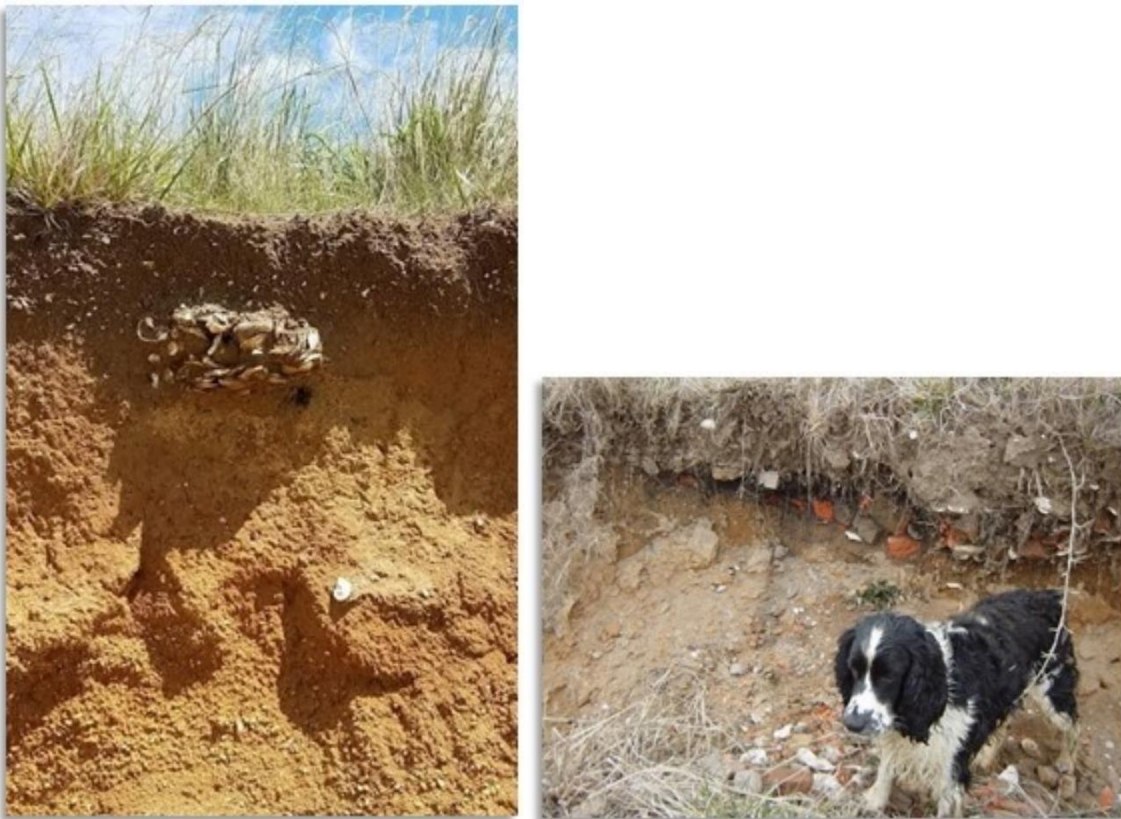
Figure 9 Erosion at the Calverton Archaeological Site

Caption: Archaeological sites erode out of banks along the waterways in Calvert County. Photo courtesy of the Calvert County Department of Planning & Zoning

Threats to archaeological sites cannot be assessed merely by reference to projected inundation levels. Ongoing erosional processes in addition to increases in wave height owing to rising sea levels and subsidence of the land make sites far above surface water susceptible to loss. The action of the water and wind on the shore tends to undercut the shoreline which then becomes unstable and slumps onto the beach only to have the process repeat. To date, shore erosion inhibiting actions such as hardened or living shorelines and archaeological data recovery are the principal means of mitigating threats to archaeological sites.

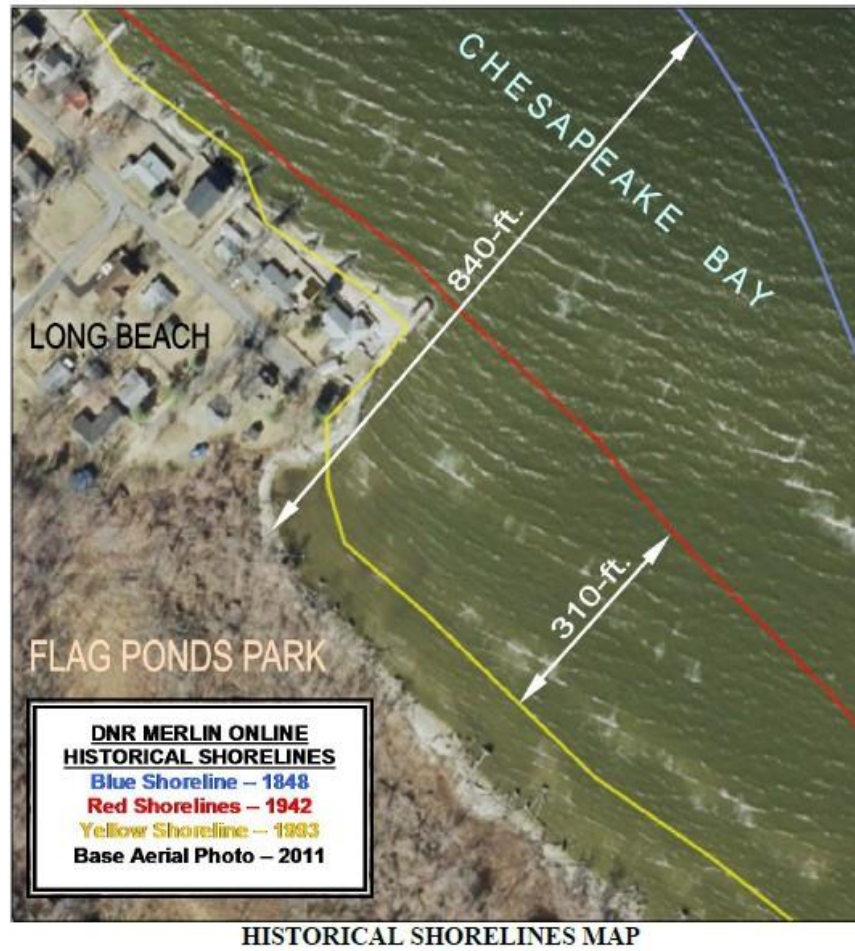
Figure 12 Historical Shorelines Map at Flag Ponds Nature Park

$$\frac{2011 \text{ shoreline (base aerial)} - 1848 \text{ shoreline (blue)}}{163\text{-year period}}$$

$$\text{Average Annual Rate of Erosion} = \frac{840\text{-ft. of shoreline recession}}{163\text{-year period}} = 5.1 \text{ ft./yr.}$$

$$\frac{1993 \text{ shoreline (yellow)} - 1942 \text{ shoreline (red)}}{51\text{-year period}}$$

$$\text{Average Annual Rate of Erosion} = \frac{310\text{-ft. of shoreline recession}}{51\text{-year period}} = 6.1 \text{ ft./yr.}$$

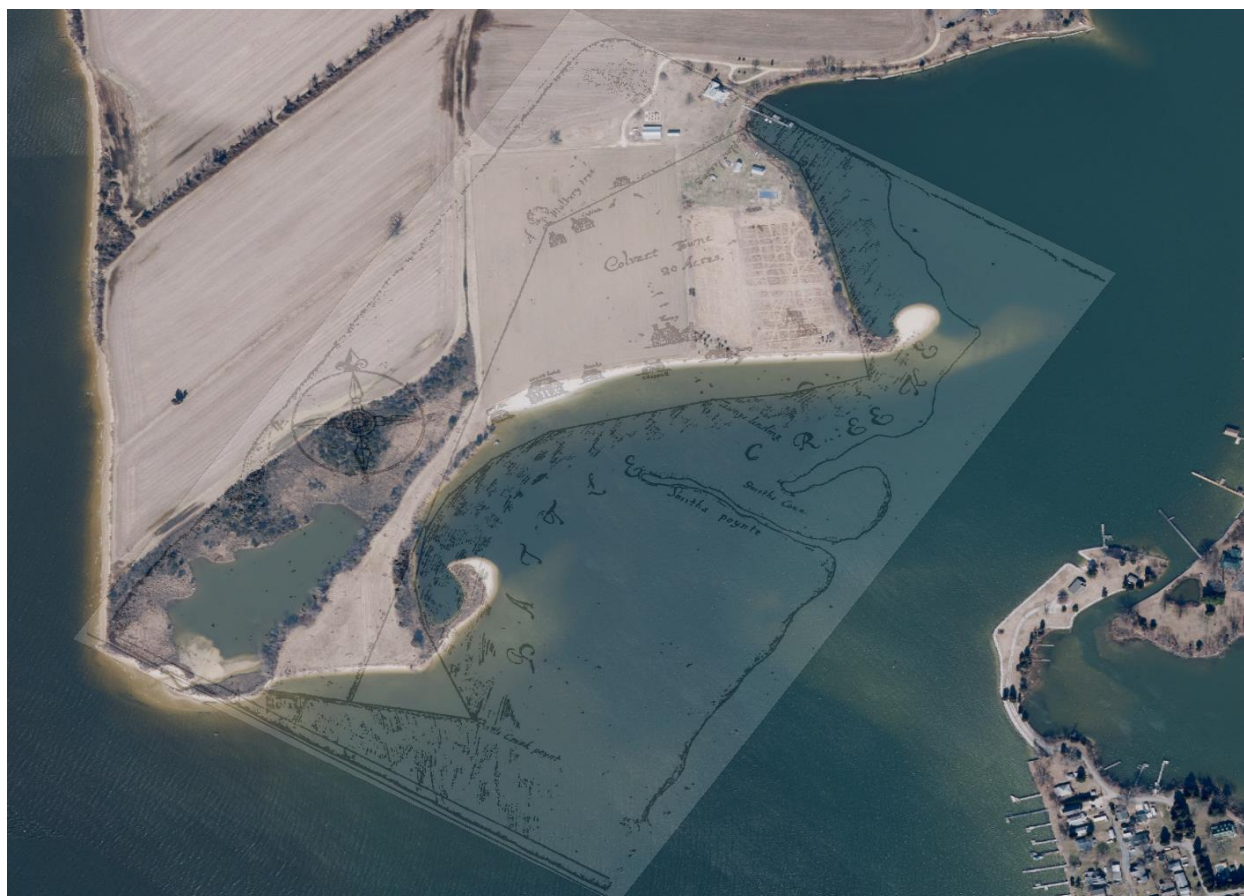
Figure 13 1682 Survey Plat of Calverton Shown Over a Modern Aerial

The 1682 town plat shows several public buildings including a courthouse, prison, and chapel, along with dwellings and outbuildings. The town was abandoned sometime after the courthouse and county seat were relocated to Prince Frederick in 1724. The former town site has since been converted to farmland after falling into disuse. In the ensuing years Battle Creek has pummeled the former waterfront at

Calverton with an estimated loss of more than 50 meters of shoreline. Archaeologists registered the 1682 plat on modern aerials of the property to show that several of the buildings are completely gone, including the prison. However, the overlay shows several buildings still located entirely on land and a couple of buildings partially eroded on the current shoreline.
